Solving Landslide Problems by Combined and Geosynthetic Reinforced Systems

D. Alexiew

Huesker Synthetic GmbH, Gescher, Germany

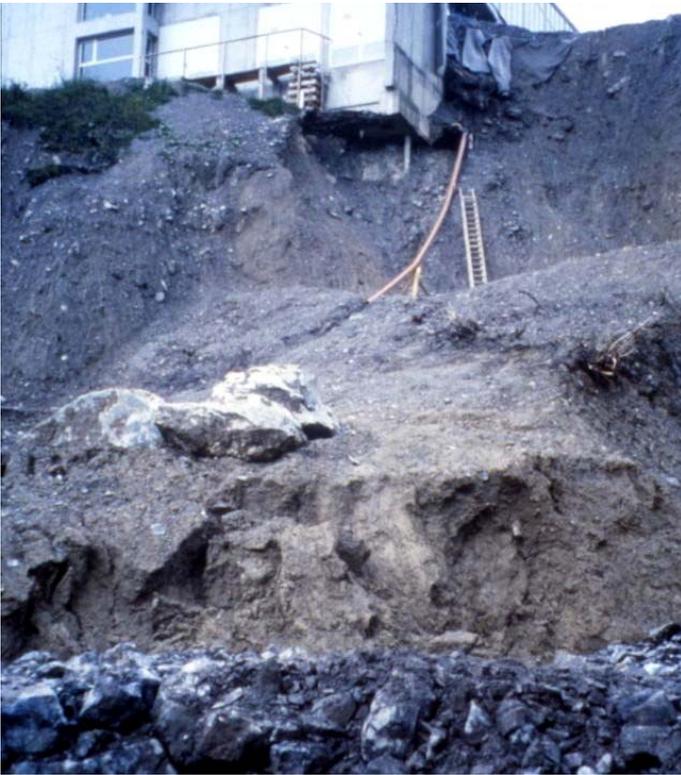
Figure 1. Steinmaderer Wand, Austria: Lift-station endangered after failure of landslide mass (1994)

In Spring 1994 a huge landslide occurred on a natural slope of about 25 m height just below a ski-lift station some kilometers above the town of Lech in the Austrian Alps. The slid soil masses blocked the road at the toe of slope. The upper part of the sliding surface reached very quickly the foundation of the lift station on top of slope destroying the earth platform in front of the station and endangering the entire building (Fig. 1).

The main reason for the slope slide seemed to be oversaturation resulting in overpressure and effective soil strength reduction due to increased water inflow from behind which was localized mainly in the bottom half of slope. A quick stabilizing and slope-reconstruction solution had to be found and executed as soon as possible and to be completed in less than three months until September 1994, the beginning of the ski-season.

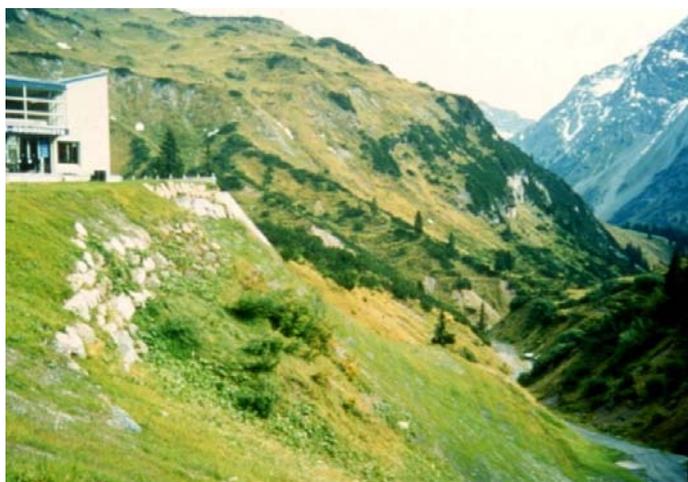
Figure 5. Steinmaderer Wand: green reinforced slope completely integrated in the landscape (1995 until now)

The solution proved to be successful from any point of view over nine years until now (Fig. 5).

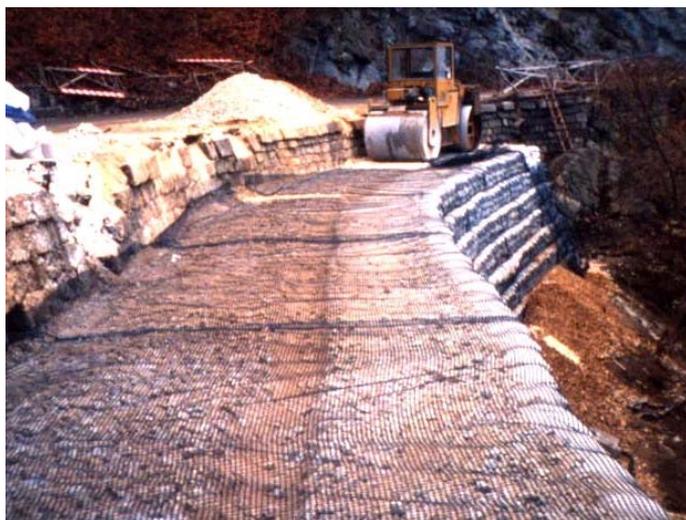
Figure 7. Jugovsko Hanche: construction of geogrid-reinforced wall, top part of old stone masonry retaining wall to the left

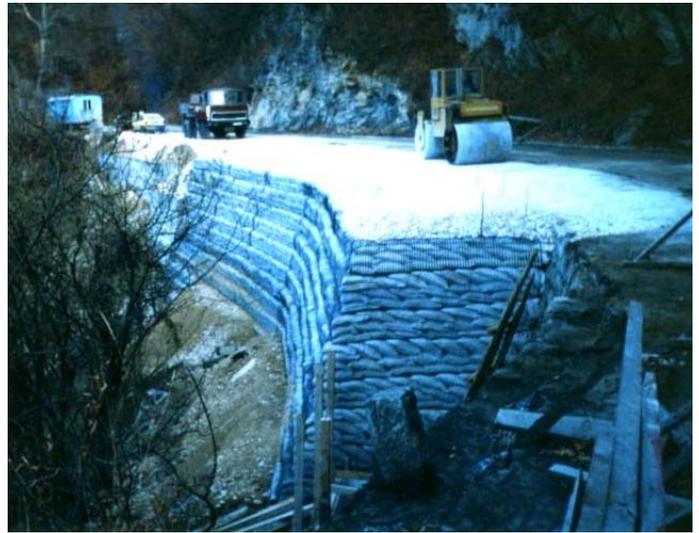
Figure 8. Jugovsko Hanche: completing landslide stabilization and road widening (before installation of the final Muralex® facing)

The combined system presented was cheaper and easier to build than e.g. a second new concrete or RC-wall. A new type of green facing was used in front of the geogrid wall (the so called “Muralex®”) to meet the environmental (landscape) requirements. The entire system was successfully built up in less than two months in Autumn 2000 by a local contractor without any problems despite its lack of experience with geogrid reinforcement (Figs. 7, 8), confirming the easiness of construction. An “inner formwork” of well sand-filled bag was applied during compaction in the front area. The technique is easy and efficient in combination with flexible geogrids (Fig. 8).

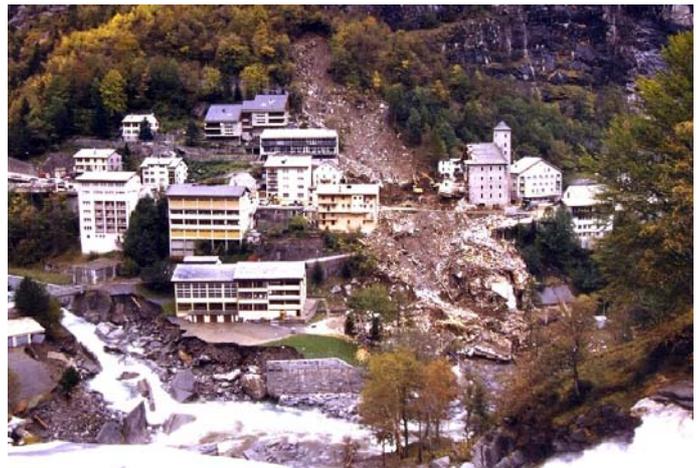
Figure 9. Gondo: catastrophic stone-rock avalanche

At the town of Gondo in Switzerland a stone-rock avalanche which was provoked by snow thawing destroyed in Spring 2002 some houses and blocked the main road (Fig. 9).

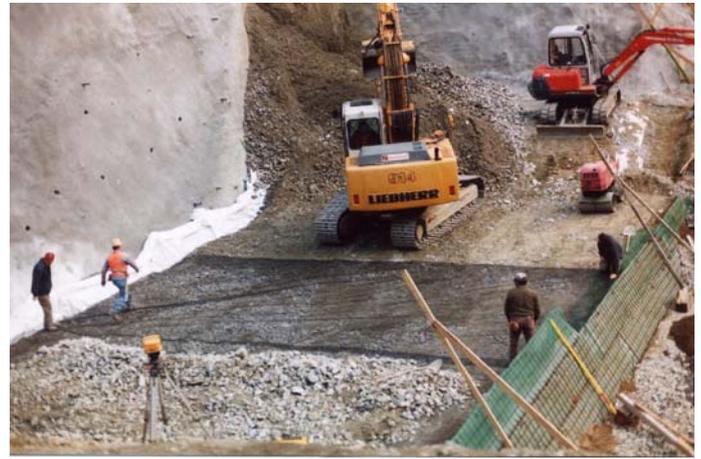
Figure 11. Gondo: start of construction; Fortrac®200-geogrid, fill layers and facing installation

The relatively strong geogrids Fortrac® 200 and Fortrac® 150 were necessary not only due to the big height of 20 m, but also due to the consideration of dynamic loads from stone avalanches or rock impact on the upper site of wall. On Figure 10 the old existing terrain is also shown. To ensure both the external stability of the structure and the so called “compound mode of failure” (a failure surface crosses both the geogrid-reinforced and the non-reinforced zone behind and/or below, Alexiew & da Silva (2003)). The protective wall had to be embedded in the existing slope. An additional reason was to block potential flat instability zones parallel to the old terrain line. A temporary steep excavation was done and temporarily fixed by shotcrete (Fig. 11), then the installation of the geogrids, soil layers and facing started. Attention was paid to an appropriate drainage system (Fig 10). This is always an important issue for geogrid reinforced earth walls and may not be underestimated, because the consequence can be a loss of stability due to pore overpressure or hydraulic driving forces. Construction was completed in less than two months (Figs. 11, 12).

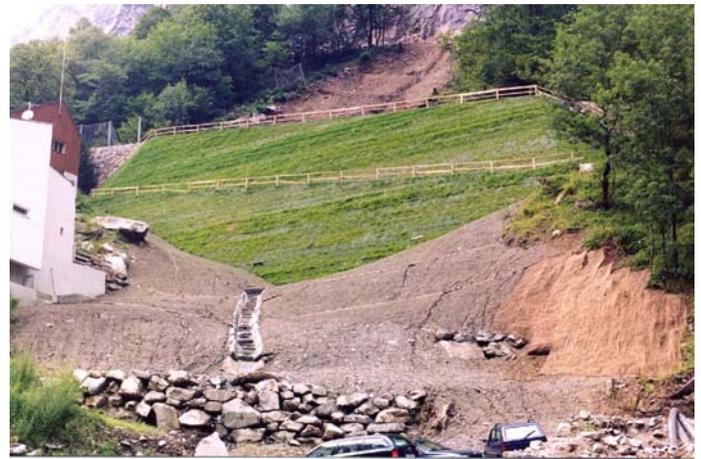
Figure 12. Gondo: wall completed; well harmonizing with the environment
